New Generation Runway Visual Range (RVR) Final Operational Test and Evaluation Report: Volume I

July 1996

DOT/FAA/CT-TN95/32-1

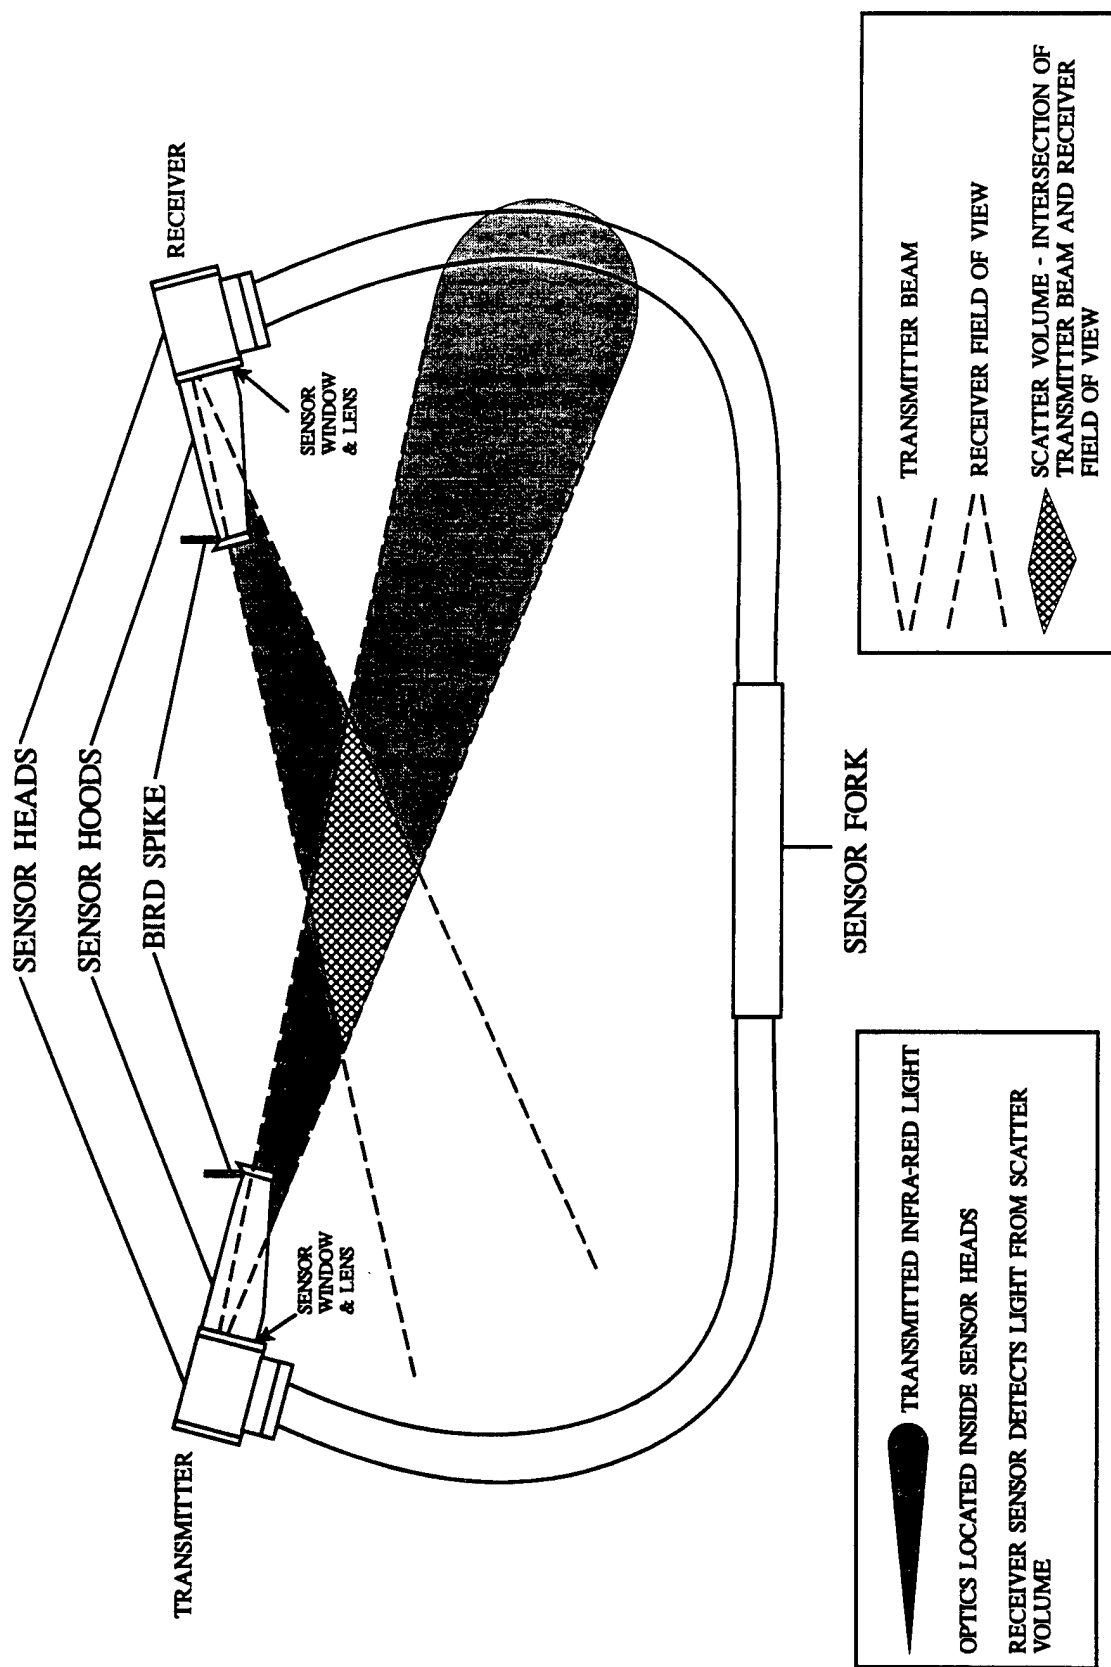
FIGURE 1. LOOK-DOWN VISIBILITY SENSOR COMPONENTS

"Window Signals" originating from the RVR's window contamination detection circuitry were found to be adversely affected by precipitation hitting the lens or "window" (figure 1) of the VS. These signals are actually voltage levels which are proportional to the amount of contamination detected on the sensor lens. Window contamination includes any substance such as snow, water, dirt, etc., that might strike or collect on the sensor window. Effects of precipitation striking the sensor window ranged from errors in extinction coefficients to sensor shutdowns. Because of shutdowns, it was necessary to disable the software modules involved in contamination correction. This effectively eliminated a major functionality of the system.
